REPORT #1089  
SUPPLEMENTAL MAINTENANCE MANUAL  
AND  
INSTRUCTIONS FOR CONTINUED AIRWORTHINESS  
FOR MODELS: W-100-X

This manual is not a substitute for the original maintenance manual which was supplied with the type certified balloon system. It is intended as a supplement for the purpose of providing continued airworthiness information and guidelines to be used with the following envelope models: W-100-3, W-100-4, W-100-5 and W-100-6.

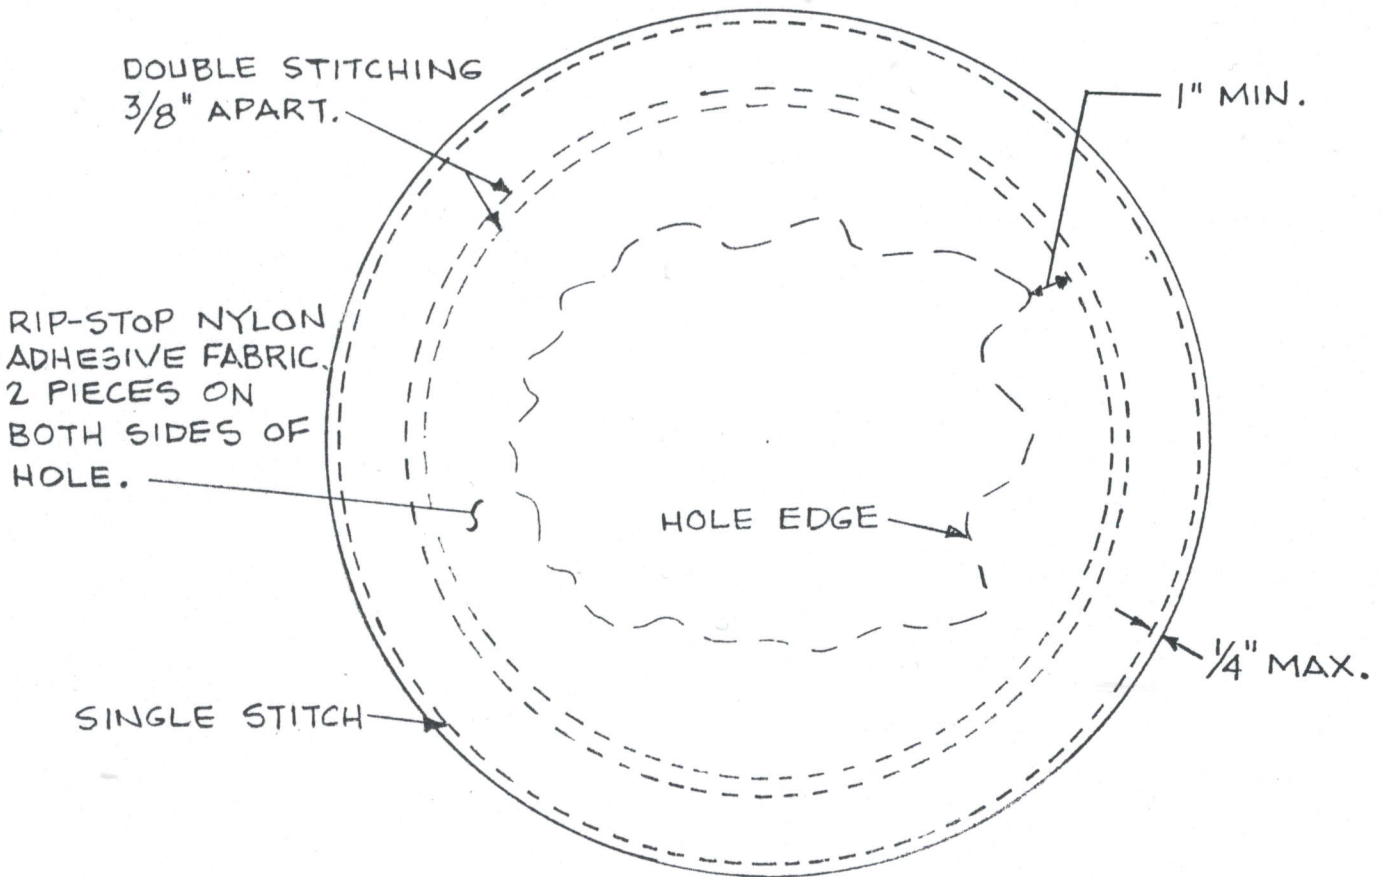
APPENDIX A

Repair To Fabric Holes

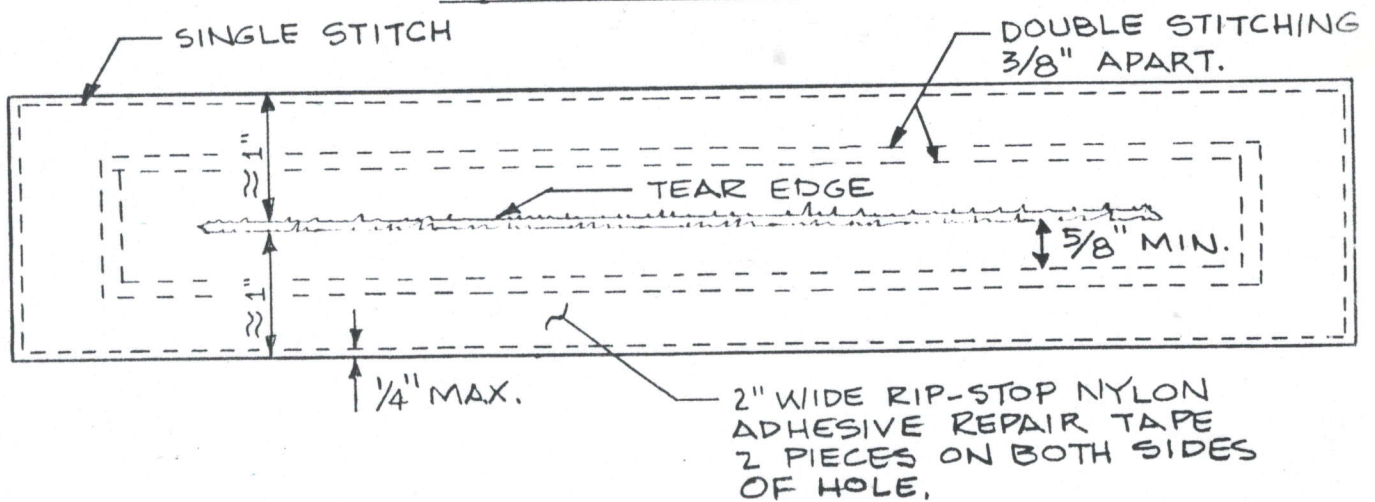
APPENDIX B

Repair To Fabric Tears

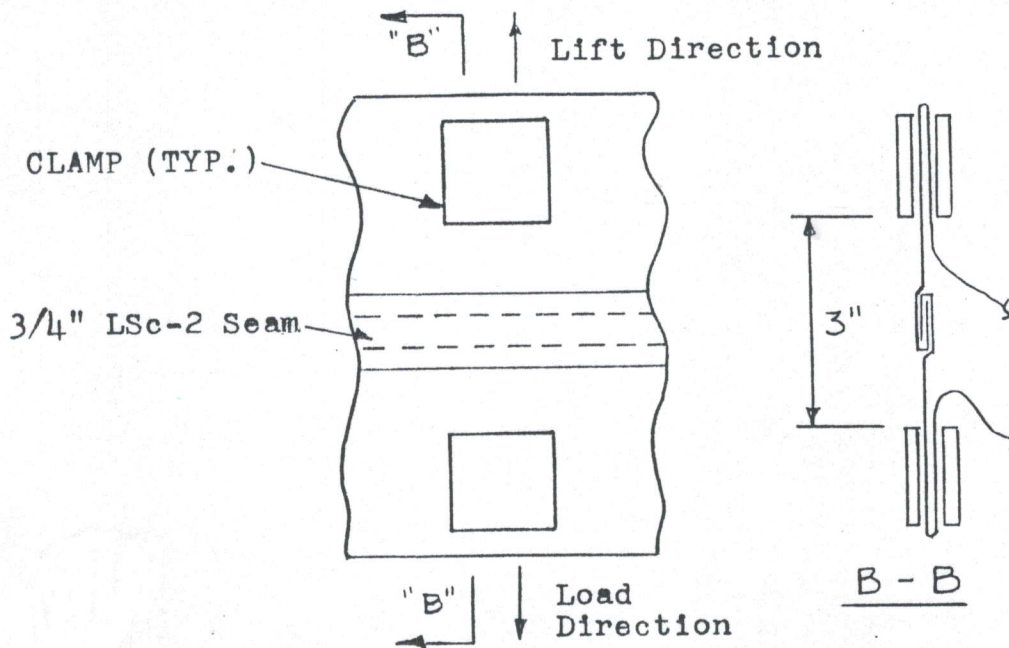
APPENDIX C

Envelope Fabric Strength Test

The test specimen will usually involve one of the upper envelope center gore seams. Using the lines of heavy rip-stop weave as a guide, the plates should be squared off at a distance of 3 inches apart straddling a center seam as shown in the diagram below. The appropriate amount of weight, including the weight of one clamp, is attached to the lower clamp. The weight is then lifted clear of the floor by the upper clamp. If the fabric strength is in doubt, the weight should be increased on the lower clamp in increments of 1 pound, starting with a total weight of 19 lbs. Weight should be added until the maximum weight is reached or until total seam failure occurs.

In order to grab the proper amount of fabric, two 1" wide clamps must be constructed as a test device. A simple and practical test device can be made using four 1" x 1" flat steel plates of 3/32" to 1/8" thickness. All four plates must be faced with rubber, measuring approximately the same thickness as the plates. Two common C-clamps may be used to compress the test samples between the plates. The weight of one of the C-clamps and plates should be determined to within .5 lbs.

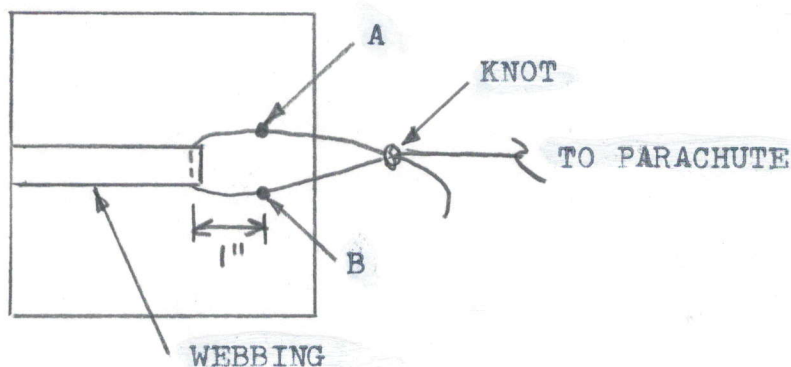
- 3) Undo the knot at the centering pad. Once the knot is removed, determine which direction the line must be moved in order to adjust the length of the line, and do so, such that the mark made on that side of the line touches the edge of the webbing loop.

UNADJUSTED

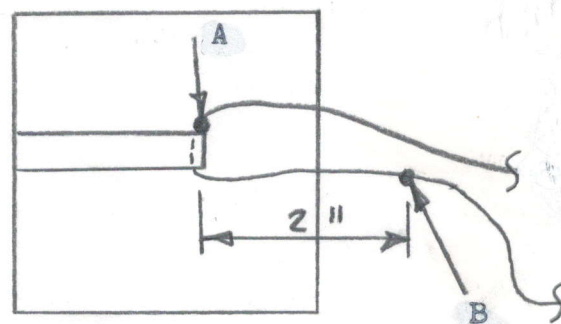
- 4) Re-tie the centering line with a bowline-8 knot so that the mark remains in the same position, touching the edge of the webbing loop.
- 5) Mark the pad with an X to identify that it's line has been adjusted, and repeat the above procedure to the remaining lines.

ADJUSTED
